# US Patent Application 10/644,220

## Copper-Nickel-Silicon Two Phase Quench Substrate

# Rim Failure Modes

# Rim Surface Failure Analysis

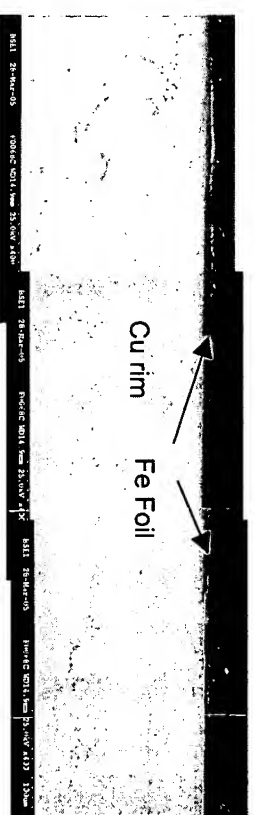
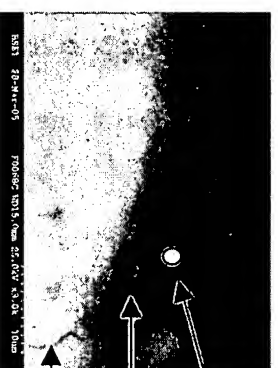
**Peeling** from welding/stripping

EDS Analysis:  
5.11Cr-25.99Fe-30.07Ni-38.82Cu

- Molten Metal Penetrates Rim Surface (at large Silicides?)
- Cu, Cr and Ni Dissolution in Fe
- Cracks Extend From Weldment

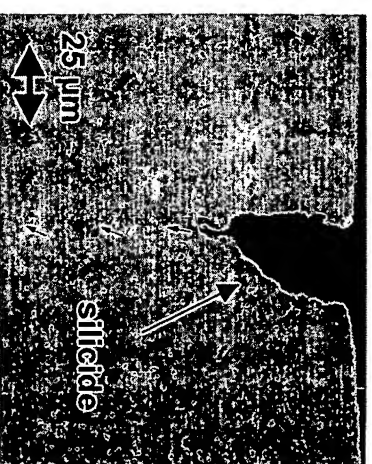
**Micro Cross Section of Rim  
Showing Pit and Silicides**

Note: Individual pit is small.  
Silicide is large (>5μm thick)

*Rim Failure Related to Non-Homogeneous Microstructure*

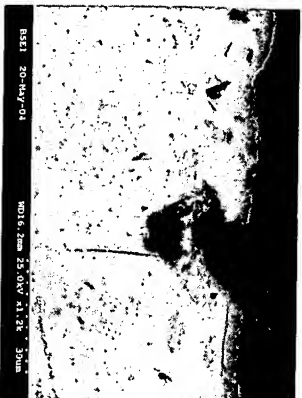
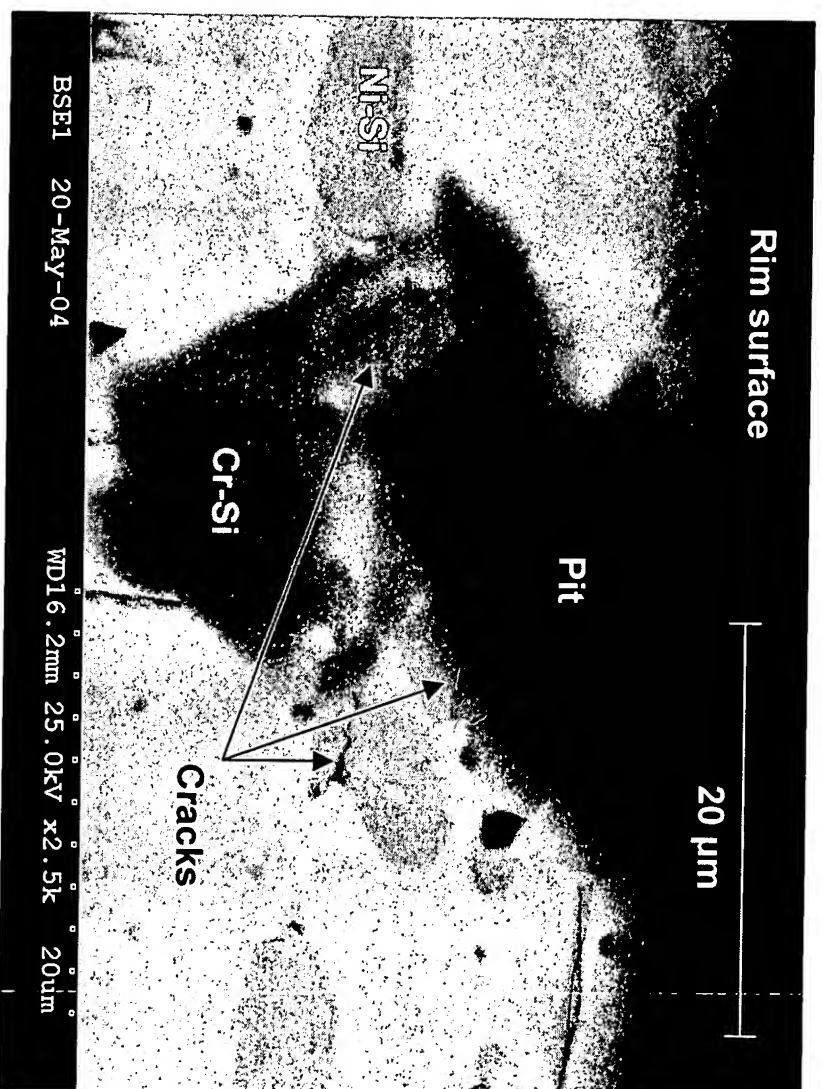
## SEM – Transverse Section

*Sub-surface Crack Networks Can Create Pits...  
Pits Can Expand Thru Continued Cracking*

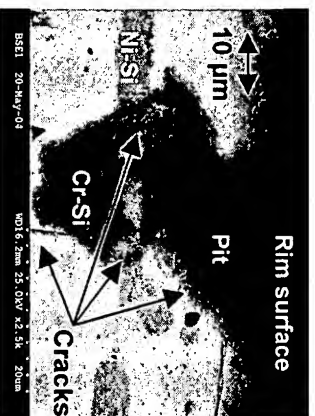
*Pit Formation via Crack Nucleation and Growth through Large Primary Silicides*

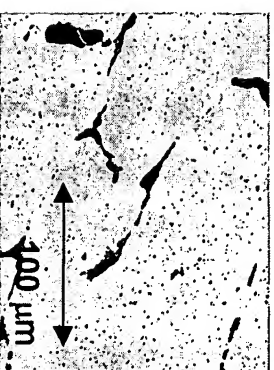
Continuous Network Rim  
Grain Size ~ 100 μm  
Silicide Size up to 500 μm<sup>2</sup>

*Rim Surface Degrades via Cracking Through Large Silicide Particles  
No Large Silicide Particles in Discontinuous Network*

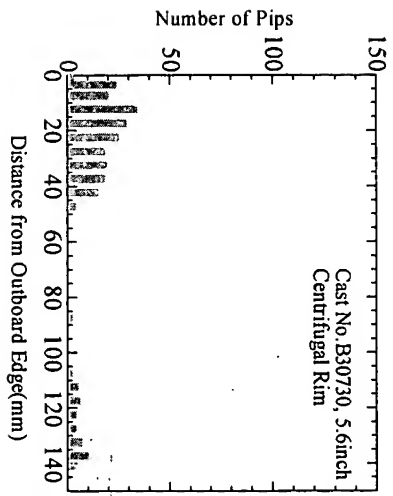
Continuous Network  
Rim

More than 50 defects

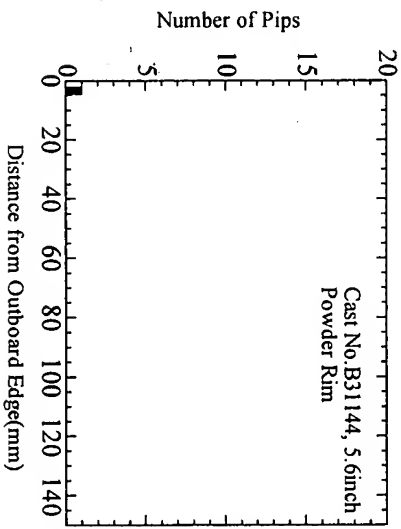
Discontinuous Network  
Rim

Less than 5 defects

Discontinuous Network Rims Exhibit Reduced Defect Formation, Improved Quality
